AIRCRAFT ACCIDENT REPORT

EASTERN AIR LINES, INC.
DOUGLAS DC-9-31, N8984E
CHARLOTTE, NORTH CAROLINA
SEPTEMBER 11, 1974

NATIONAL TRANSPORTATION SAFETY BOARD
Washington, D. C. 20594
REPORT NUMBER: NTSB-AAR-75-9

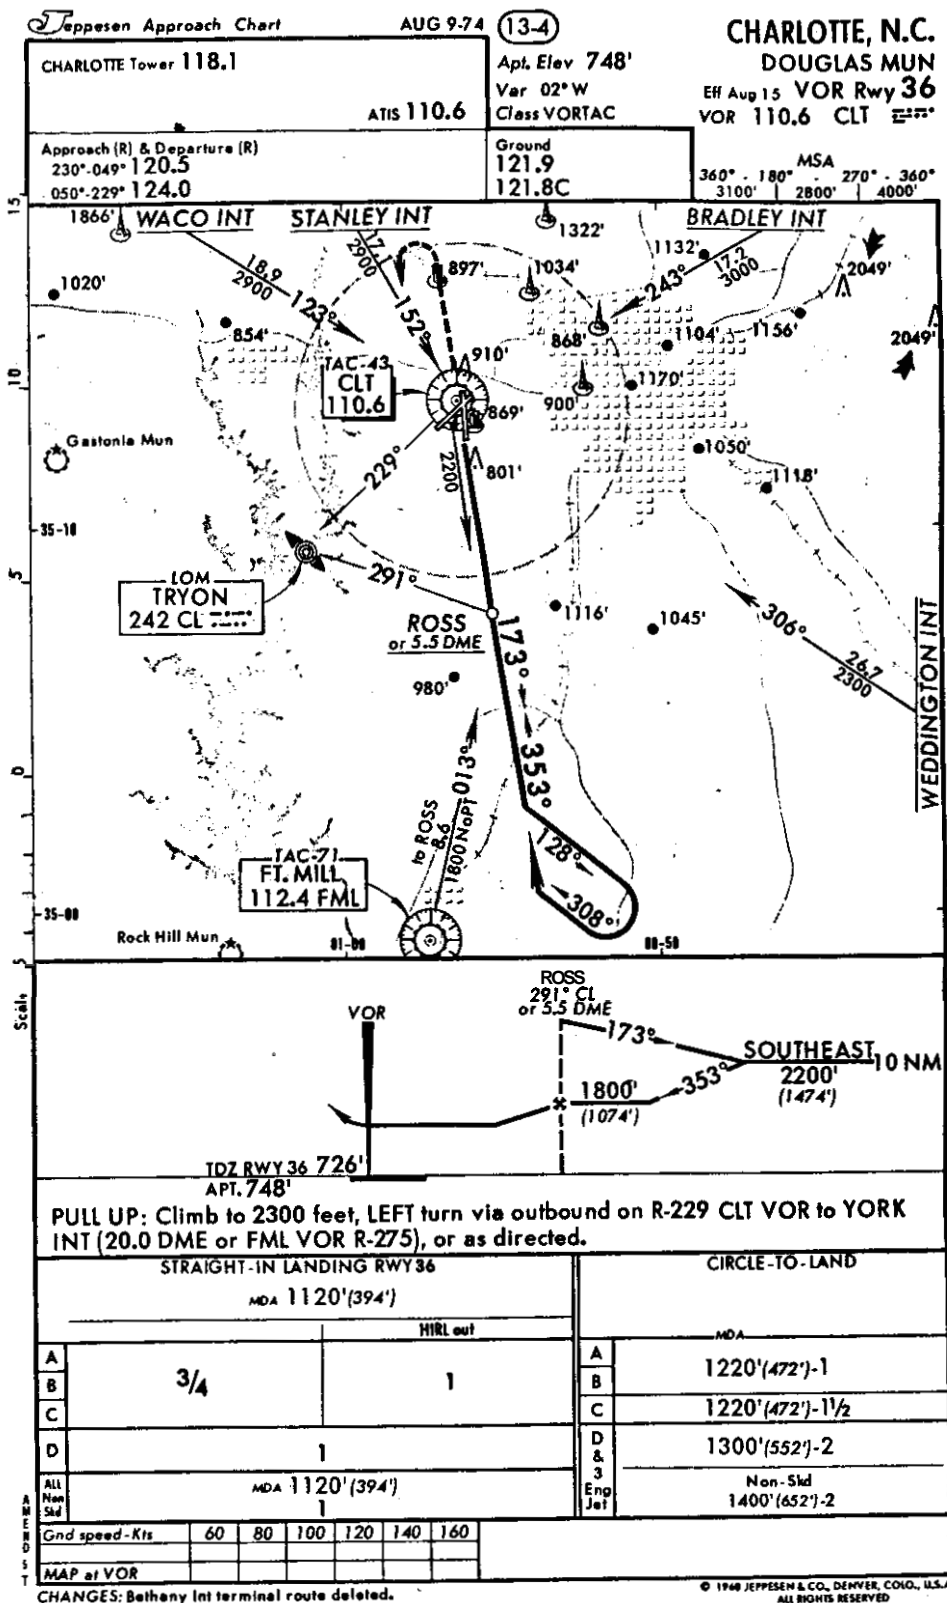
APPENDIX D

A VORTAC, 11/ located on the airport about 1.1 nmi from the approach end of runway 36, is used for nonprecision approaches to the runway. The VOR 36 approach is made inbound on the 173° radial to cross the Ross Intersection, located at 5.5 nmi from the VORTAC, at about 1,800 feet (1,074 feet above the touchdown zone). After an aircraft passes Ross, descent is authorized to a minimum descent altitude (MOA) of 1,120 feet (394 feet above the touchdown zone). (See Appendix D)
