**NATIONAL  
TRANSPORTATION  
SAFETY  
BOARD**

**AIRCRAFT ACCIDENT REPORT**

CONTINENTAL AIR LINES, INC.,  
McDONNELL-DOUGLAS DC-10-10, N68045  
LOS ANGELES, CALIFORNIA  
MARCH 1, 1978

AAR-79-1

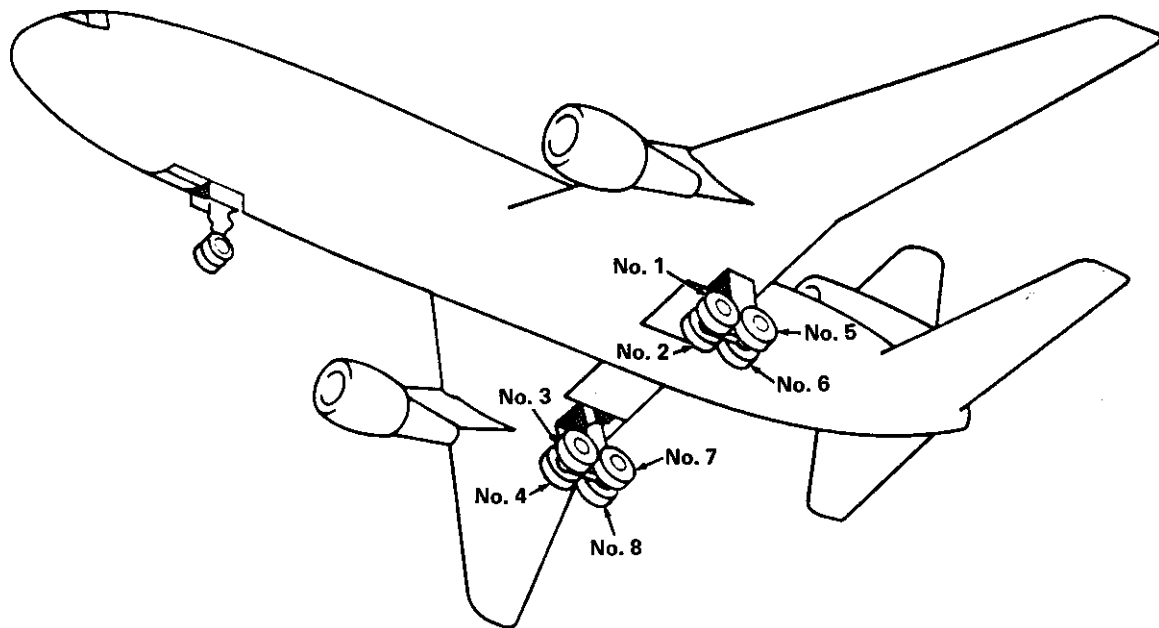
Figure 1. DC-10-10 main landing gear tire/wheel assembly positions.

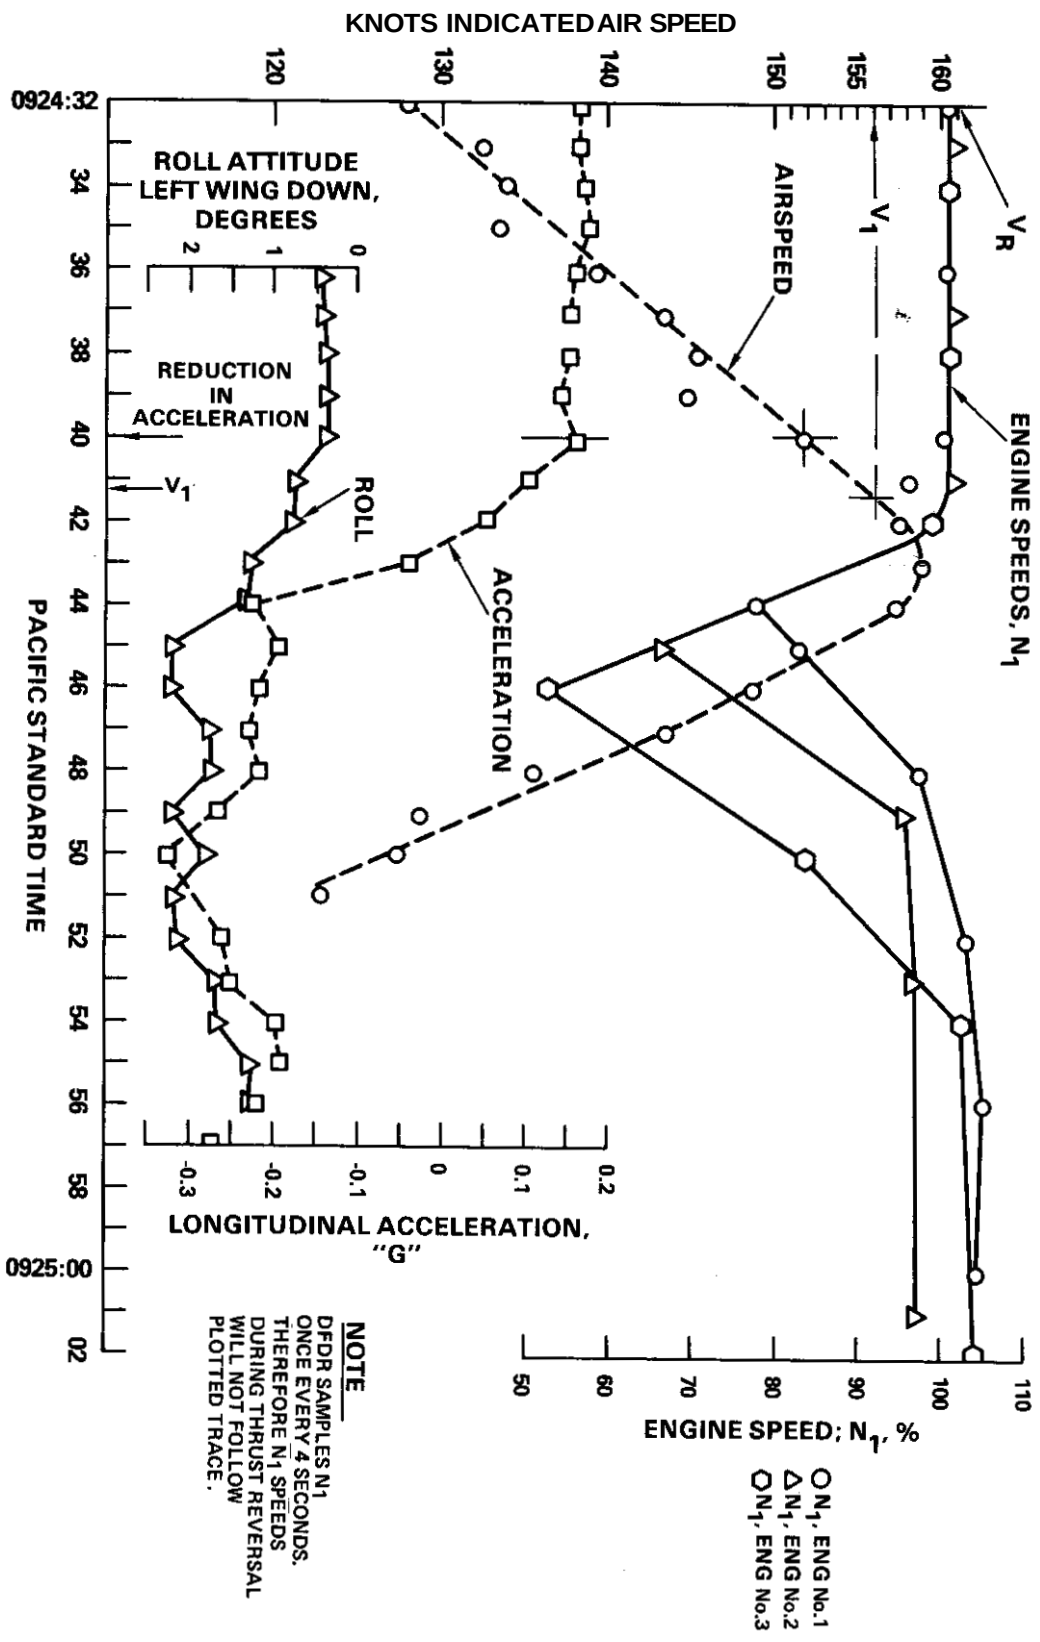
The DFDR data showed that the takeoff roll began from a static position on runway 6R at 0923:54. (See figure 2.) The wing flaps were set at 5°. Takeoff thrust was established at 101-percent  $N_1$  on all engines as the aircraft accelerated through 37 kns. At 152 kns, 46 sec into the takeoff roll and 4 kns below  $V_1$ , the longitudinal accelerometer began recording a marked decrease in the aircraft's acceleration although takeoff thrust was being maintained on all engines. No indications of tire failure were evidenced below 152 kns by the DFDR. At 152 kns, the DFDR roll attitude parameter began to record a gradual lowering of the left wing.  $V_1$  speed, 156 kns, was reached 1.2 sec later, or 47.2 sec after the start of the takeoff roll. Engine thrust began to be reduced less than 0.5 sec after  $V_1$  speed. A maximum speed of 159 kns, 2 kns below  $V_R$ , was recorded 1.8 sec after  $V_1$  and 0.5 sec after longitudinal acceleration had changed from positive (acceleration) to negative (deceleration) values. Thrust reversers unlocked while the airspeed was decelerating through 157 kns at a peak deceleration rate of  $-0.23g$ . About 1.2 sec later, the thrust reversers were deployed at 152 kns as the engines were spooling down for thrust reversal and as the left wing reached its maximum down attitude of 2.1'. The engines began to spool up for thrust reversal 4.8 sec after  $V_1$ ; maximum reverse thrust values were attained in 3 sec on the center engine, in 6 sec on the left engine, and in 8 sec on the right engine. Aircraft heading began to deviate to the right of the runway centerline as full reverse thrust was being attained. The heading reached 079°, the maximum deviation from the centerline, as the aircraft's speed decelerated through 58 kns.

Figure 2. Aircraft performance before, after RTO initiation.

A peak vertical acceleration value of 1.22g was recorded 20.8 sec after  $V_1$  indicating the end of the runway. The airspeed at this time was decelerating through 68 kns with reverse thrust being maintained at 104- to 105-percent  $N_1$  speed on the wing engines and at 100-percent  $N_1$  speed on the center engine. Three sec later, the aircraft heading began a rapid turn to the left simultaneous with a sudden  $10^\circ$  lowering of the left wing. The left engine speed also decreased suddenly. Peak engine speeds for the center and right engines were recorded 1 sec later. Engine speeds began to decrease on the center and right engines at airspeeds of 57 kns and 30 kns, respectively. The last recorded airspeed was 30 kns.

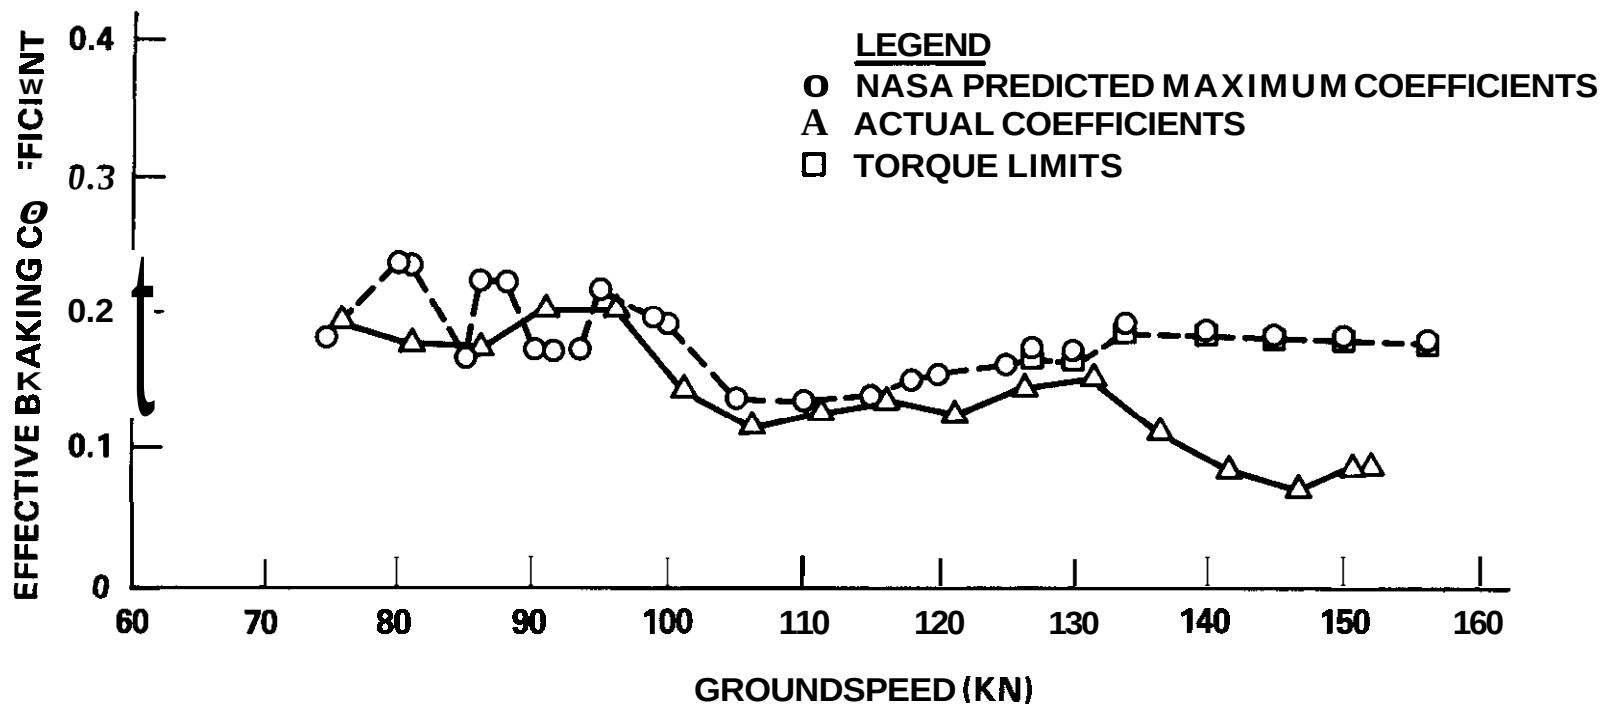
The actual rejected takeoff braking performance for the Continental DC-10 was calculated using DFDR data and aerodynamic data. These calculations produced a relationship between effective tire-to-pavement frictional coefficients and aircraft groundspeed. When these results were compared to the NASA-predicted maximum braking coefficients over the same speed range, substantial differences were found in the 153 kts to 132 kts groundspeed range, during which the aircraft traveled about 1,200 ft in the initial portion of the takeoff. For groundspeeds between 132 kts and 68 kts (the end of runway speed), the Douglas and NASA braking values substantially agreed, indicating that maximum braking was being achieved over the last 2,250 ft of runway. (See figure 4.) Three possible reasons for the disagreement above 132 kts are: (1) The values predicted by NASA could have been excessive, (2) temporary loss or delay in antiskid system operation, and (3) the crew could have applied less than maximum brake pressure. If the predicted braking levels above 132 kts had been achieved, the aircraft might have stopped intact about 200 ft beyond the departure end of the runway. The Safety Board was not able to quantify the actual amount of braking effort applied by the crew or to accurately determine why the full braking values predicted by the NASA theory were not achieved.

Figure 4. Comparison of actual and predicted maximum braking capabilities.
